# Manhole Inspection Summary

Manhole # S41I\_\_011MH

Insp Date: **5/15/08 8:26 AM**

**Location** Address: **300 s central ave**

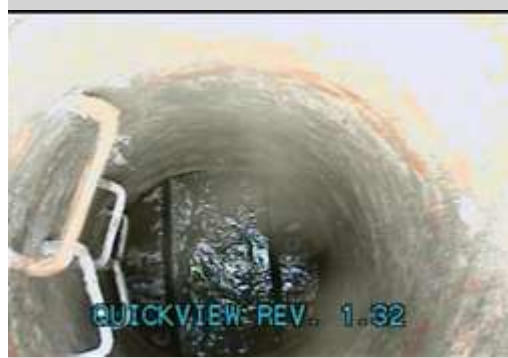
Top View

top view & steps

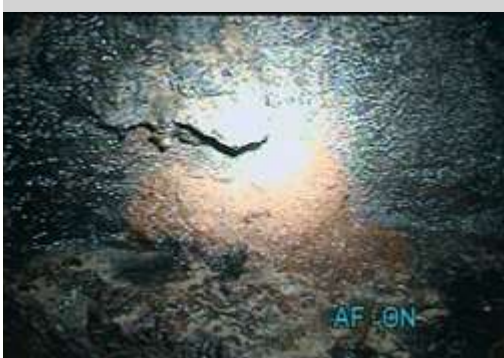
Defect 2

**Barrel** Material: **Brick** ☐ Parged

Condition: ☐ Sound ☐ Cracked ☐ Root Intrusion ☐ Loose Brick ☒ **Deteriorated**

Infiltration: ☐ None ☐ Joint ☐ Cracks ☐ Mortar ☐ Roots ☒ **Wall**

barrel deteriorated with infiltration from wall

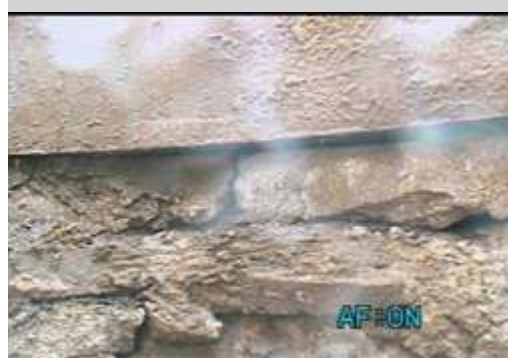
Defect 1

**Chimney / Frame Adjustment** ☒ Exists Material: **Brick and Concrete** ☐ Parged Height: **6** (in.)

Condition: ☐ Sound ☒ **Cracked** ☐ Root Intrusion ☐ Loose Brick ☐ Deteriorated

cracked, frame adjustments

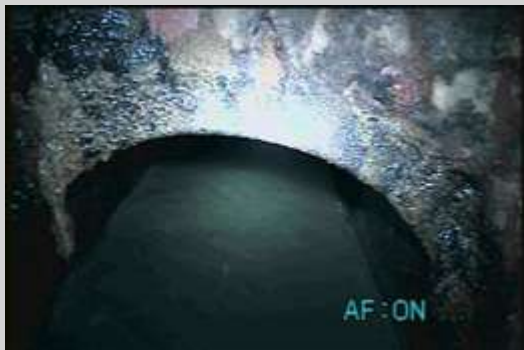
12 O'Clock Outflow

27 in. Circular Gravity Sewer  
Pipe Out @ 12 O'Clock

Pipe Material: **Clay** ☐ Pipe Lined

Invert Depth: **12.28** (ft.) Flow Characteristics: **Fast**

Infiltration: **None** Pipe Seal Cond: **Unknown**

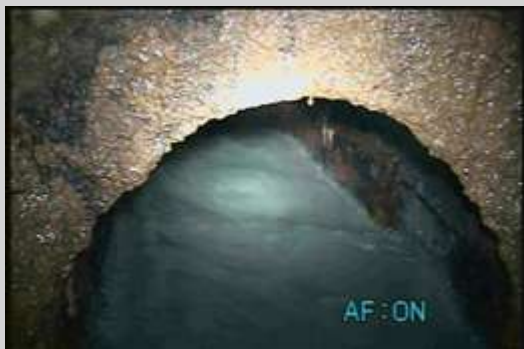
6 O'Clock Inflow

27 in. Circular Gravity Sewer  
Pipe In @ 6 O'Clock

Pipe Material: **Clay** ☐ Pipe Lined

Invert Depth: **12.20** (ft.) Flow Characteristics: **Fast**

Infiltration: **None** Pipe Seal Cond: **Unknown**
